## CYLINDER HEAD GASKETS MORRIS EIGHT 1934-38

### A few observations following recent discussions regarding localized overheating.

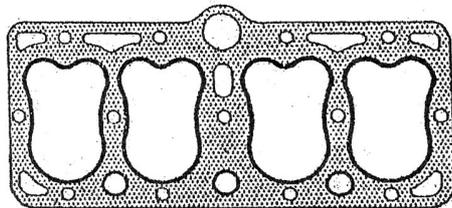
**Morris Eight Series I/II**

- If the earlier gasket (Series I / II diagram; Payen AA 680) is used, the coolant will be diverted via the water passage between cylinders 2 and 3 and will enter the cylinder head satisfactorily. But there is a chance that the larger distributor aperture in the gasket could lead to potential failure at the water passages near to the distributor hole.
- If the later gasket (Series E diagram; Payen AA 250) is used, coolant will be blocked (it cannot be diverted in this area) from entering the cylinder head via the water passage between cylinders 2 and 3, and this is likely to cause localized overheating and potential failure.
- Surely we need a 'hybrid' pattern gasket. In effect an early type (Series I/II diagram) pattern but with the reduced size distributor hole

I believe that is important that any gasket on these engines has sufficient 'maximum' width around the distributor aperture. Some I have seen do not, and create a weakness at an important area. I think a third pattern 'hybrid' gasket in addition to those shown below is required when fitting a UB type cylinder head to a later engine block; in other words a Series I/II pattern gasket but with the smaller distributor hole. It would seem to be advisable that the gasket manufacturer should be asked to make a special copper/asbestos 'hybrid' version.
